**A POWER QUALITY REVIEW  
FOR  
A Fast Food Restaurant**

**METER-TREATER, INC.**

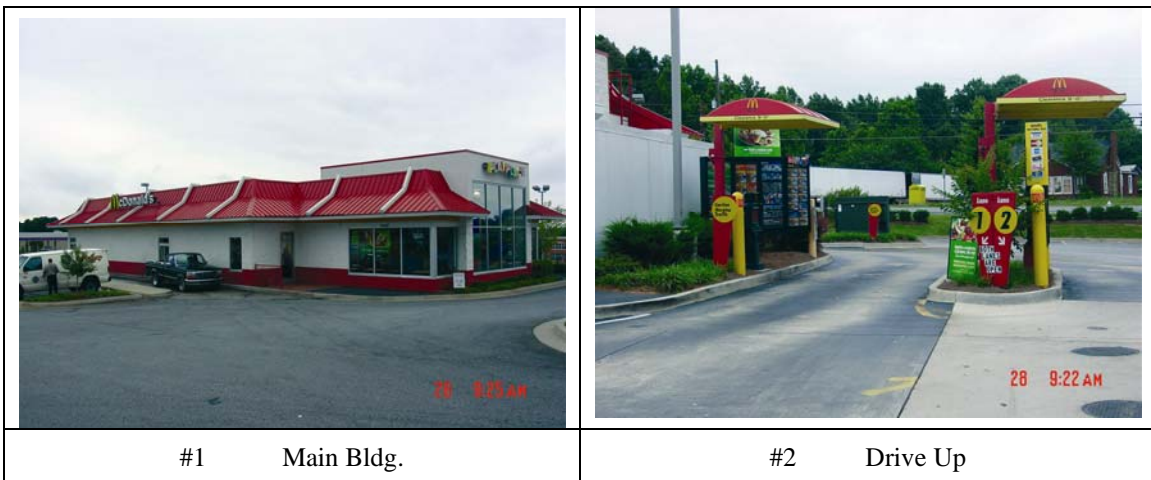
The installation is a single-story structure with detached service ports for drive up service (photos 1 & 2).

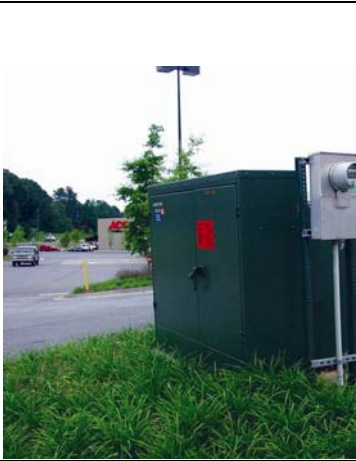
A 300kV transformer supplies ac power to the site (photo # 3). The main facility entrance is a Square D High Line Panelboard, (photo # 4). The main ground rod was not located.

<p># 3: Utility Transformer</p>	<p># 4: Main Panel Board</p>	<p># 5: 120/240 Panel</p>

Test confirmation of the site's ground system from the utility transformer to the main panelboard and in turn to both ac sub-panels should be accomplished as soon as possible.

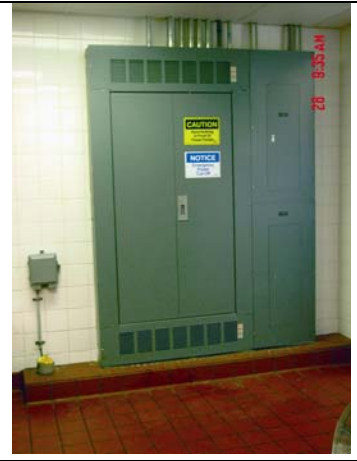
The main ac distribution panel or panelboard is located internally along a wall in the restaurant (photo# 4). Panelboard ratings are 1kA for 277/480 volt 3phase service.

- a. Primary (incoming) Lines: The telephony demark is located next to the main ac panel board and has primary protection in place (see photo # 4); however; there is no evidence of any secondary protection for modems and like equipment.

Install a Hardwire Surge Protection Device, suitable for service entrance locations, on the main AC Panel (Model RCHW, MST, BPT or MPT).

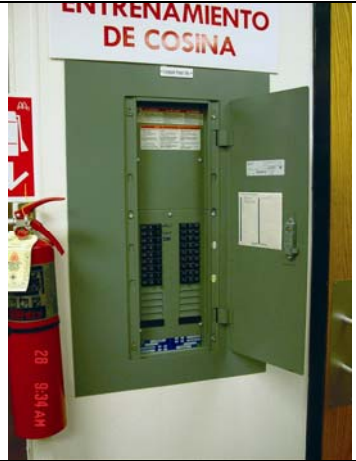
The second panel (photo # 5) is rated as a 125 Amp 120/240Volt, Split Phase Wye device. This panel, labeled for computer use, appears to service the office-networked equipment (photos #6 – 10).

Install additional Surge Protection Devices on each of the two sub-panels (Model RCHW, MST or BPT).

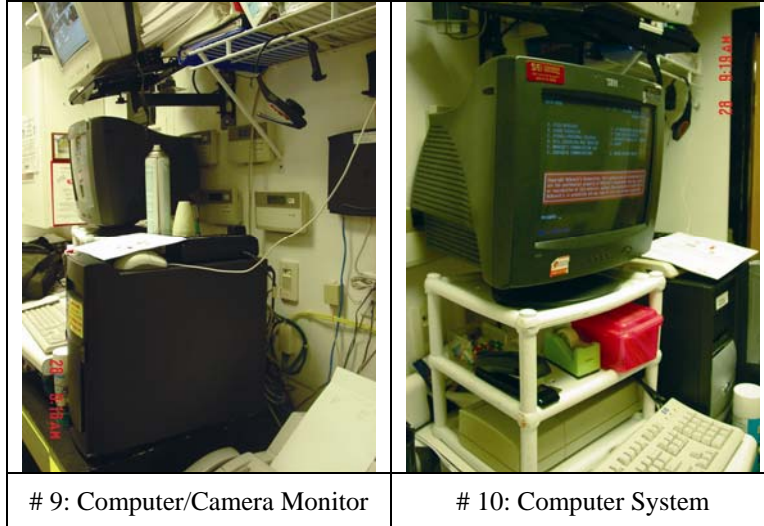
2. **Video/Security/Sound System:** The video monitor/recording system is not properly bonded to the facility ground and it is not protected from surge voltages. According to on site personnel the equipment had received damage from the last storm/surge event. The security/alarm system was not reviewed (see photo #6).
3. **Computer:** The computer located in the office is critical to daily operations. It must be able to communicate with the outside world via its modems. It is provided with a UPS backup system but there is no protection evident on the modem interface.

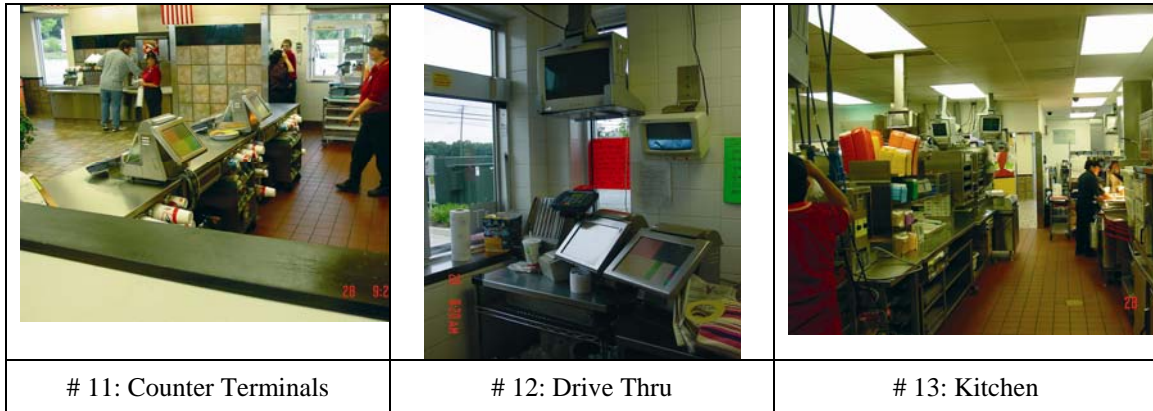
There was no power quality protection noted on any of the other operating sections of the restaurant. Point-of-sale terminals, fryers, and drink equipment were noted as not protected.

The drive through window provides transients an excellent ingress into the facility.

It would be prudent to place point-of-use surge protective devices on all pos terminals, drink machines and any other sensitive equipment. This recommendation is for both the ac power and the data/signal ports (Model TST, HLP and TrippLite SPDs).
