SITE INSPECTION REPORT

A Ski Resort

METER-TREATER, INCORPORATED
1349 South Killian Drive, Lake Park, Florida 33403
Toll Free: (800) 638-3788
www.metertreater.com

The specific subject of this report is the Ski Resort's Chile Express ski lift. The information and subsequent recommendations contained herein result from data obtained during a site inspection of the subject lift.

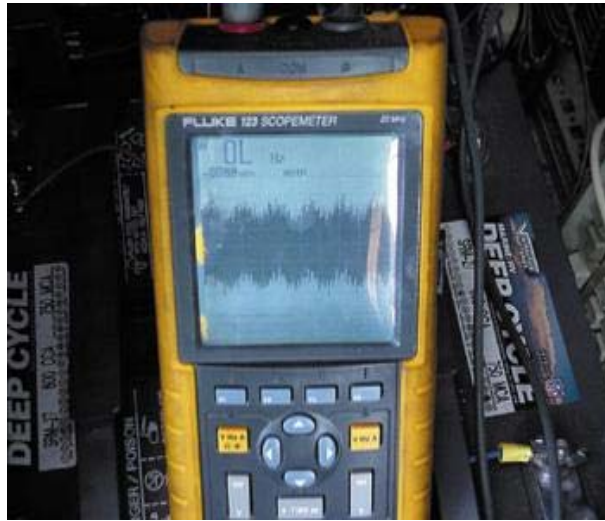
Figure #1

- Figure 1 shows significant signal distortion on communication wires between upper and lower control shacks.

In figure #1 the signal appears degraded and shows a significant amount of noise. Disconnecting the old style carbon surge protectors, located at both ends of the communication wires, reduced the amount of signal noise dramatically. Some harmonic distortion and random noise was still evident; however the

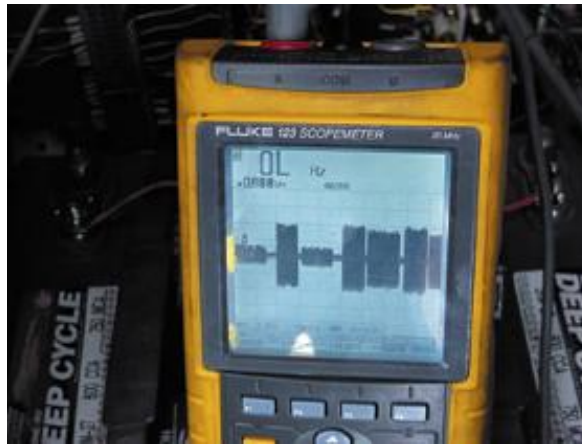
Figure #2

amount (shown in figure 2) was significantly less than with the carbon suppressors online.

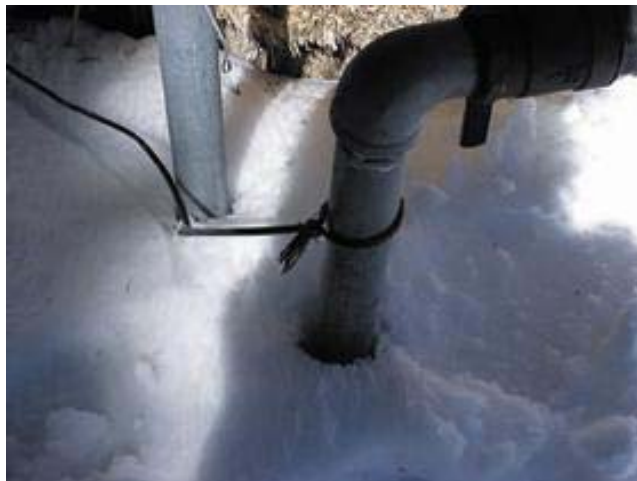
8. It was not possible to take actual ground resistance measurements due to the extreme hardness of the frozen rocky landscape and limited time. All parties acknowledged that the ground resistance is relatively poor due to the type of rock and soil present. The altitude and distance from the water table heighten the inadequacy of grounds. There is a ground rod and ring installed at the lower lift shack. A ground rod with an attached 1AWG wire running to the snowmaking water piping near the upper shack was present (figure 3).

Figure #3: Ground attached to water pipe.

The temporarily twisted 1AWG wire on the water pipe appeared to slightly reduce the amount of noise on the communication circuit.

Poor grounds are a major concern. Reduction of signal noise at the upper shack of the Chile Express by temporarily attaching the water pipe indicates that the upper shack ground system is insufficient. A detailed grounding survey is required to determine the type and placement of a grounding system that would be adequate. Lightning events and time tend to reduce the effectiveness of grounding systems. Regular inspections of facility grounding are a necessity. Failure to perform inspections and preventative maintenance usually results in poor performance and downtime.

- a. Upgrading the electrical grounding of the Chile Express must be a major priority as soon as weather conditions permit. A detailed grounding survey is required and placement of additional ground rods maybe necessary.
- b. Ensure that all grounding points are tied (bonded) together to prevent damaging circulating currents from forming.
- c. Connect communication line shields at one end only to avoid circulating currents.

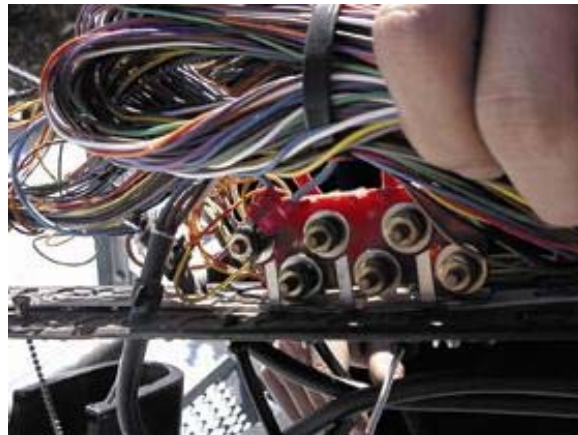
Figure #4

14. Inspection of communication lines on towers revealed no moisture present.

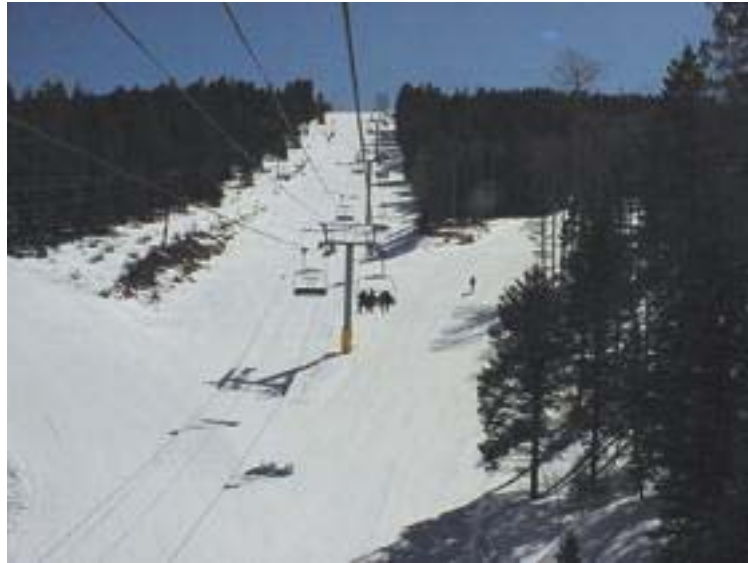
The impedance of the wire significantly degrades the communication signal. Stray signals received by the wire due to electromagnet radiation and induced voltages further reduce lift reliability. Due to the extremely weakened communication signal, cellular phones and hand held radios used by guests can cause a breakdown in lift communication data and result in an IO fault. The communication wire runs in a straight line nearly perpendicular to magnet north for over two miles. This orientation makes the data line susceptible to induced noise from solar events.

Figure #5: Chile Express Lift

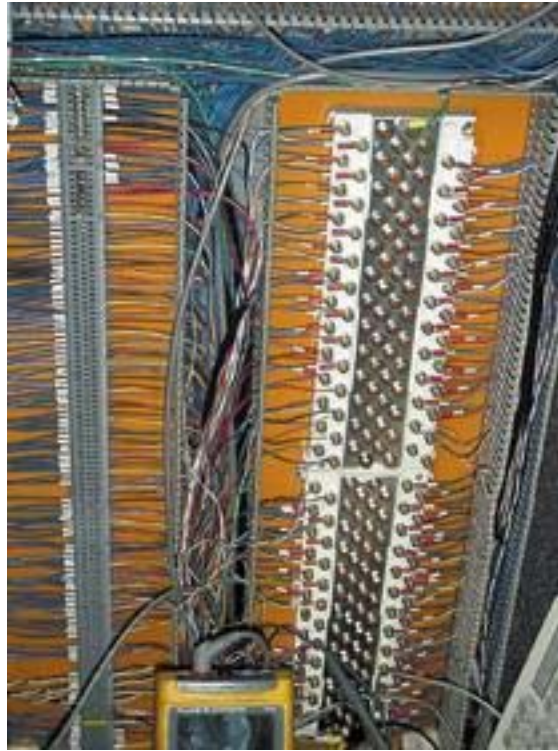
Figure #6: Carbon Block Suppressors

Communication Lines: Replace carbon suppressor blocks on the Chile Express (figure 6) with more up-to-date surge suppression technology.

Rational: The use of gas tubes, silicon diodes or a combination of these two devices provides a tighter control of transient energies without the RF noise interference associated with carbon suppressors.

Replace carbon block suppressors on all Chile Express communication and monitoring circuits. Carbon type suppressors have unpredictable failure modes and frequently place a significant amount of unwanted noise on data communication lines.

Rational: Following a transient event, carbon block suppressors pit and with each additional transient event the pitting gets worse. The pitting not only produces noise it also raises the clamping threshold of the device to the point where it may become no longer effective as a suppressor. A silicone-gas-tube hybrid technology is the preferred choice over carbon based technology for survivability and noise reduction. (Model SLT-HEB and SLT/SO)
